Corrosion of three propellers in a boat operating in Ria de Aveiro (Portugal)

A.C. Bastos,¹ C. Lemos,² O. Karavai,¹ M. Starykevich,¹ A. Rocha,¹ D.E.L. Vieira,¹ M. Oliveira,¹
R. Sampaio,¹ C. Gomes,¹ M.G.S. Ferreira¹

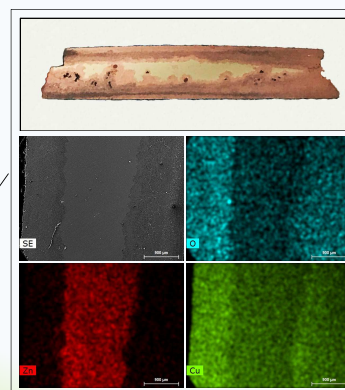
Propeller 3
No signs of dezincification after 9 months of operation
