INSTANTANEOUS ON/OFF POTENTIAL MEASUREMENTS AS A TECHNIQUE TO EVALUATE THE EFFECTIVENESS OF INTERNAL CORROSION CONTROL OF COATED CARBON STEEL WATER STORAGE TANKS WITH ICCP AFFORDED

V. Ojeda¹

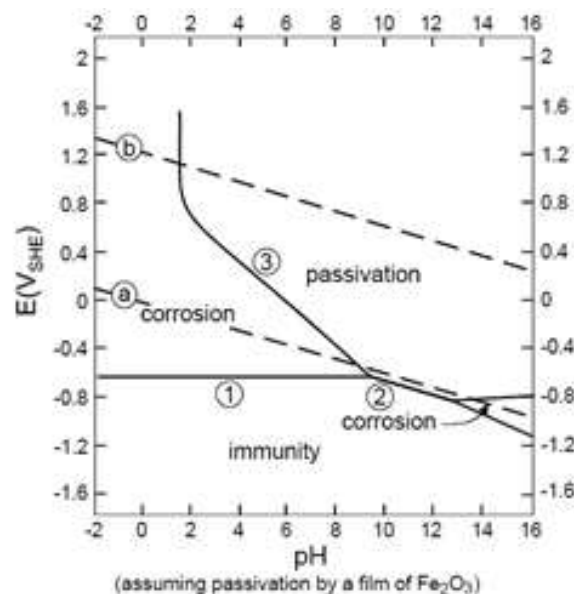
Figure 1. Pourbaix diagram (equilibrium E vs. pH) with the thermodynamic conditions of corrosion, immunity, and passivation of iron. [2]

Corrosion is so common because most metals, such as carbon steel, are more stable as compounds than as pure metals. This is because they have a desire to move from a high energy "unstable" state to a lower energy "stable" state. A metal structure immersed in water is cathodically protected when there is a negative polarized potential of at least 850 mV with respect to a copper/copper sulphate reference electrode in contact with the electrolyte [1]. This criterion is based on the fact that the current required to protect the internal parts of carbon steel tanks must be sufficient to keep the potential of the metal at least as electro-negative as the region of stability for the metal at a given pH. See Pourbaix diagram Figure No. 1[2].

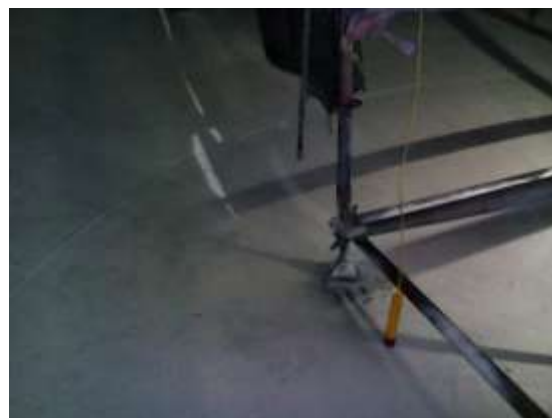
Figure 2. Permanent reference cell #4 (stub) of the bowl area inside the elevated water tank prior to commissioning.

Once the tank was in service, "native" potential measurements were recorded using stationary and portable reference cells in the bowl and riser. There are 4 stationary cells. Two in the bowl and two in the riser. In the bowl, they are located on the tank wall and on the bottom. See Figures 2 and 3. In the riser there are two more, one at the higher part and one at the bottom.

One of the bowl reference cells, the one in the lower area #4 (stub), appears to be damaged or sensitive to a coating defect. See Figure 2.

Replacing reference cell #4 would indicate if there are cracks in the coating or if the reference cell is damaged. If the reading remains outside the NACE criteria, there would be a holiday in the coating. Re-introducing portable cells from the top of the tank and recording instant off readings every meter, as was done when the tank was commissioned years ago, would give a very rough assessment of the condition of the coating and the inside walls of the tank.

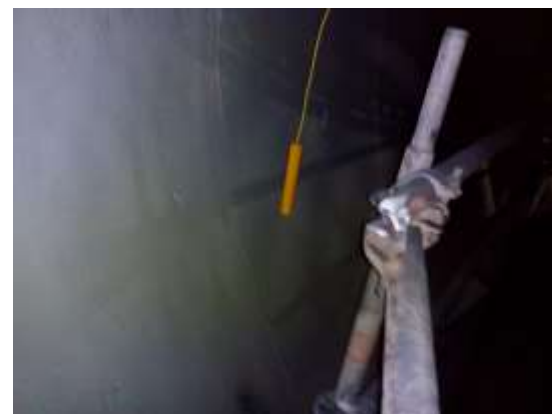
Figure 3. Permanent reference cell #3 near the wall of the bowl area inside the elevated water tank prior to commissioning.

The cell #3 near the bowl wall, sometimes works and sometimes does not. See the figure 3. The reason why this cell does not work may be because the water level in the tank is not high enough to submerge the reference cell. If the reference cell is not submerged in the water, the potential cannot be read. The times when this cell shows a consistent reading is when the tank rectifier is providing a current greater than 70 mA. See tables 3 and 4. The more metallic structure is protected, the more cathodic protecting current is delivered.

The times when reference cell No.3 gives a consistent reading is when the tank rectifier is supplying a current greater than 70 mA. If this cell fails and the one at the bottom does not give us protection readings, we will not have any accuracy of the tank protection level.
