Corrosion of three propellers in a boat operating in Ria de Aveiro (Portugal)

A.C. Bastos,¹ C. Lemos,² O. Karavai,¹ M. Starykevich,¹ A. Rocha,¹ D.E.L. Vieira,¹ M. Oliveira,¹
R. Sampaio,¹ C. Gomes,¹ M.G.S. Ferreira¹

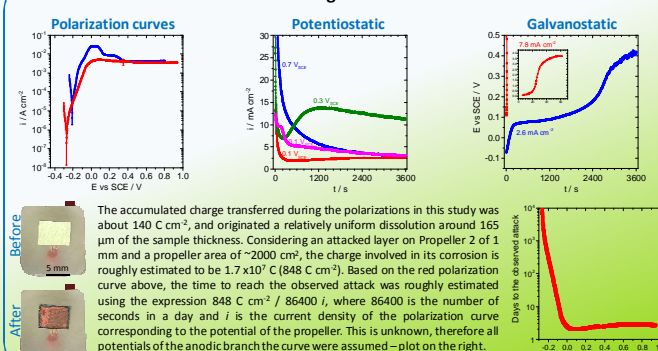
Propeller 2

Thick and compact external layer rich in copper and copper oxides. This layer appeared in just a few months. The attack was too heavy for being of natural cause. Moreover, with Propeller 2, cathodic protection was attempted and the zinc anodes and the steel supports were also dissolved.

Simulating the attack
